**REPORT ON THE INVESTIGATION  
INTO THE FIRE ON BOARD  
THE CLIPPER SHIP - CUTTY SARK,  
KING WILLIAM WALK, GREENWICH, LONDON  
SE10  
ON MONDAY 21<sup>ST</sup> MAY 2007**

29th September 2008

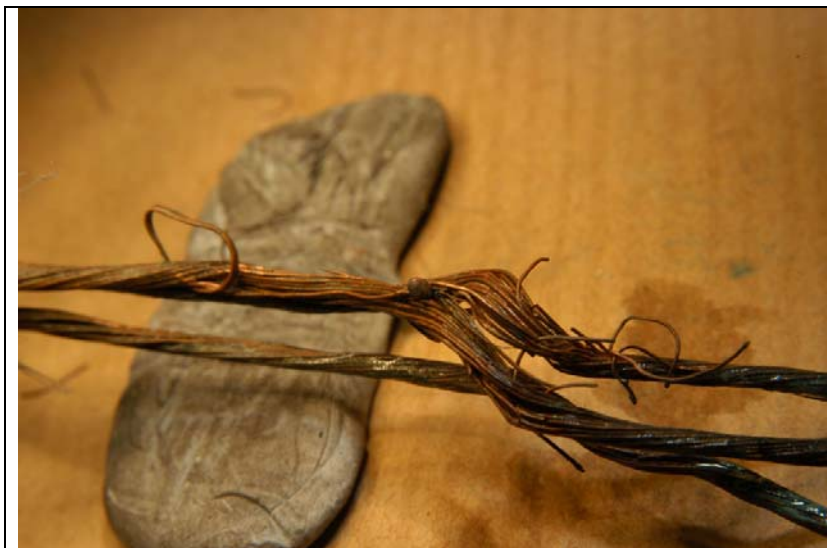
Photograph 1.

The remains of a number of electrical terminations associated with the fire-damaged fluorescent lights and their junction boxes were found in the area around the aft stairway. Parts of the circuitry had sustained very severe fire damage, such that parts of various termination blocks had melted and parts of the conductors had melted and oxidised. A severed section of flex cable, approximately 2.2 metres in length, was found at the aft end of the decking in the area of lighting terminations, and it appeared that the cable had formed part of a lighting circuit. Two of the conductors had melted locally such that the conductors were welded to one another (see Photographs 1 and 2). The adjacent parts of the conductor were not brittle or severely oxidised, and had not melted, on the basis of which, it was interpreted that the localised area of melting was as a result of electrical arcing.

Arcing damage to fluorescent lighting conductors recovered from the aft of the lower deck area. (see microscopic view of this damage in Photograph 2)

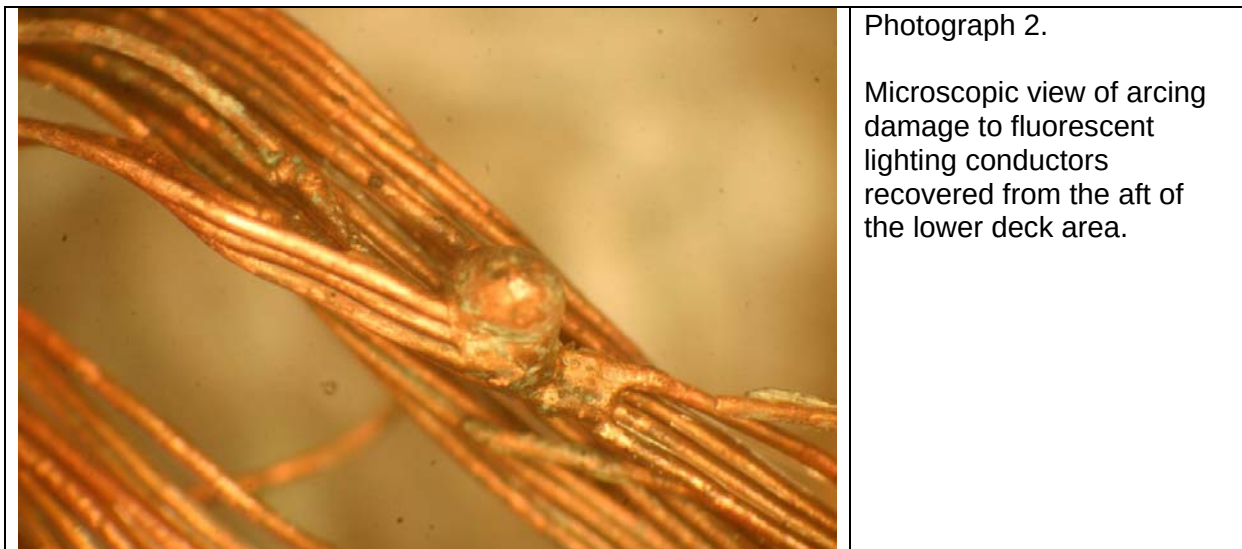
- 7.2.3 The ballasts from the seven fluorescent lights found around the aft stairway were examined, and localised damage to the winding of one ballast was identified. The ballast winding comprised a conductor looped around a laminated core. The winding had melted locally, affecting two adjacent loops of the winding, and two adjacent loops were notched.

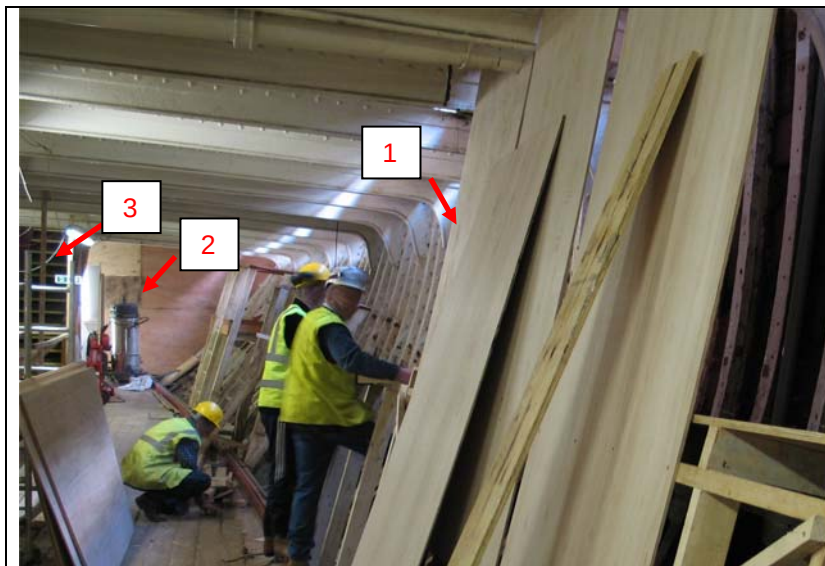
Photograph 3

View of lower deck- pre fire, showing plywood inner hull (1), and The Planet 200 vacuum cleaner (2) and the aft stairway (3).

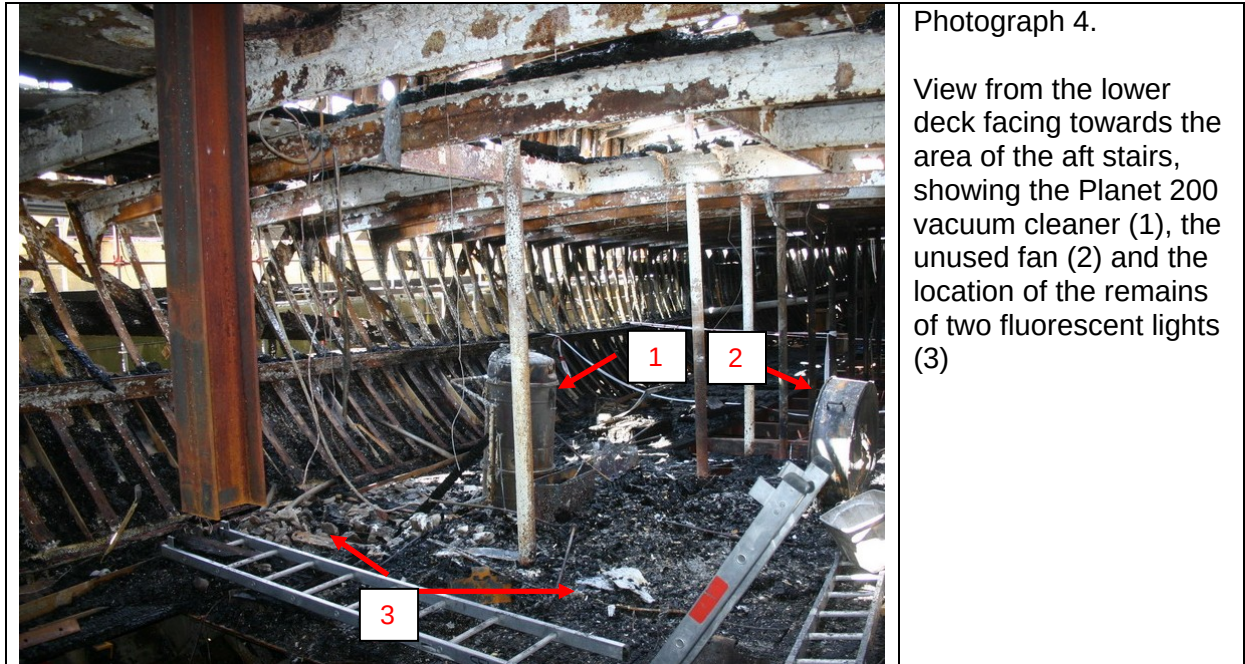
Photograph 4.

7.1.6 The only other electrical equipment found in the area was a fan (see Photograph 4 – page 36), the cable for which was coiled around the appliance, such that it is clear this was not connected to a power supply at the time of the fire, and a small electric drill, the plug for which had not been inserted into an electrical socket outlet at the time of the fire.

View from the lower deck facing towards the area of the aft stairs, showing the Planet 200 vacuum cleaner (1), the unused fan (2) and the location of the remains of two fluorescent lights (3)

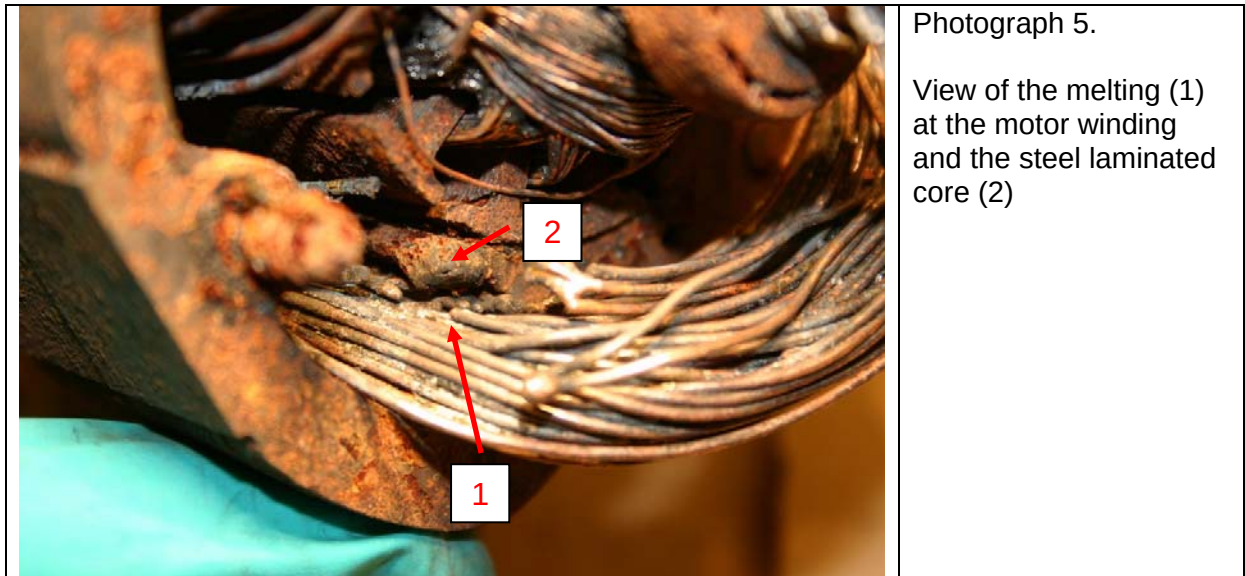
quantities of combustible material remaining. The electrical circuitry from the unit was examined in a laboratory. The unit contained three motors and associated switches. There were no combustible parts remaining, such that it was not possible to determine the position of the switches at the time of the fire. Each motor had two stator windings. Parts of the windings of one of the motors had melted. The steel laminations had melted adjacent to the area of the winding that was most grossly melted (see Photograph 5).

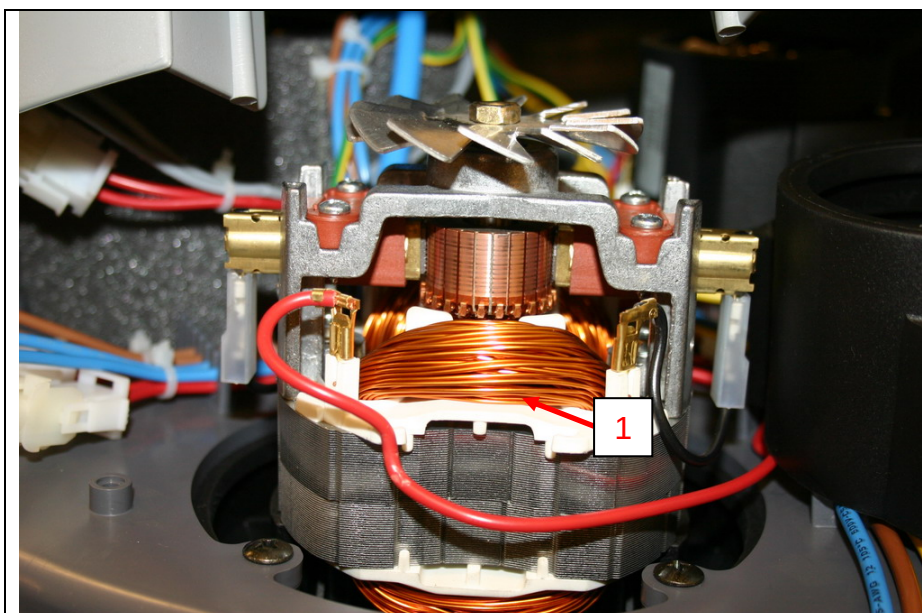
Photograph 6.

View of a new Planet 200 vacuum cleaner motor, with black plastic casing removed showing new motor windings (1)

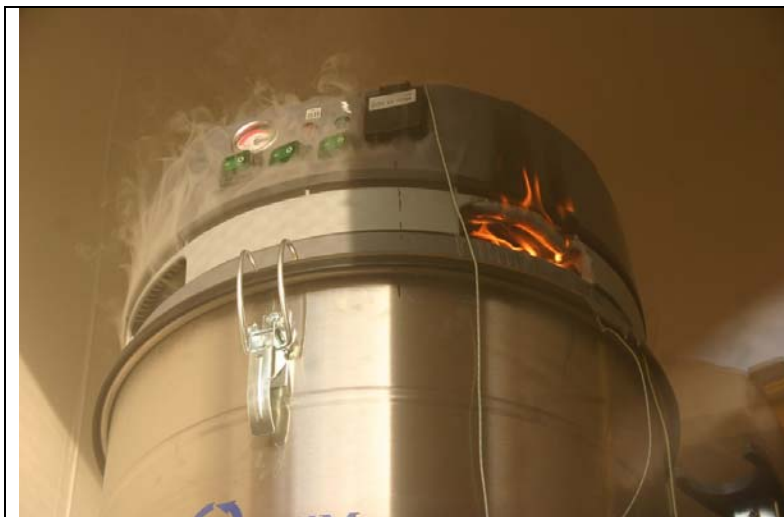
Photograph 7.

The flames appeared first at the right side of the unit when viewed from the front. Small pieces of burning material fell to the floor and continued to burn approximately four minutes after flames were first observed (see Photograph 7 - taken 3 minutes after flames were first observed). After fifteen minutes of burning, a substantial portion of the plastic parts of the appliance were involved in the fire, and flames extended above the top of the unit. After approximately 27 minutes of burning, the front of the steel dome had dropped down towards the steel body of the appliance, as much of the plastic parts had been consumed by the fire (see Photograph 8). After 38 minutes of burning, larger quantities of burning material fell to the floor, subsequently causing the hose to ignite. After approximately one hour the unit was still burning, but the size of the flames at the head had decreased in size.

The Planet 200 vacuum cleaner, approximately 3 minutes after flames were first observed.

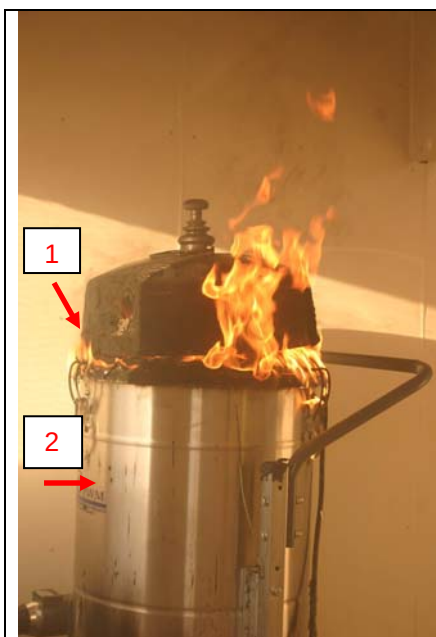
Photograph 8.

The Planet 200 vacuum cleaner approximately 27 minutes after flames were first observed. Much of the plastic support within the unit has been consumed by the fire, resulting in the front of the steel dome (1) dropping down towards the debris collection canister (2)
