Issued December 2, 2021

MAB-21/26

## Diesel Generator Engine Failure aboard Offshore Supply Vessel *Ocean Intervention*

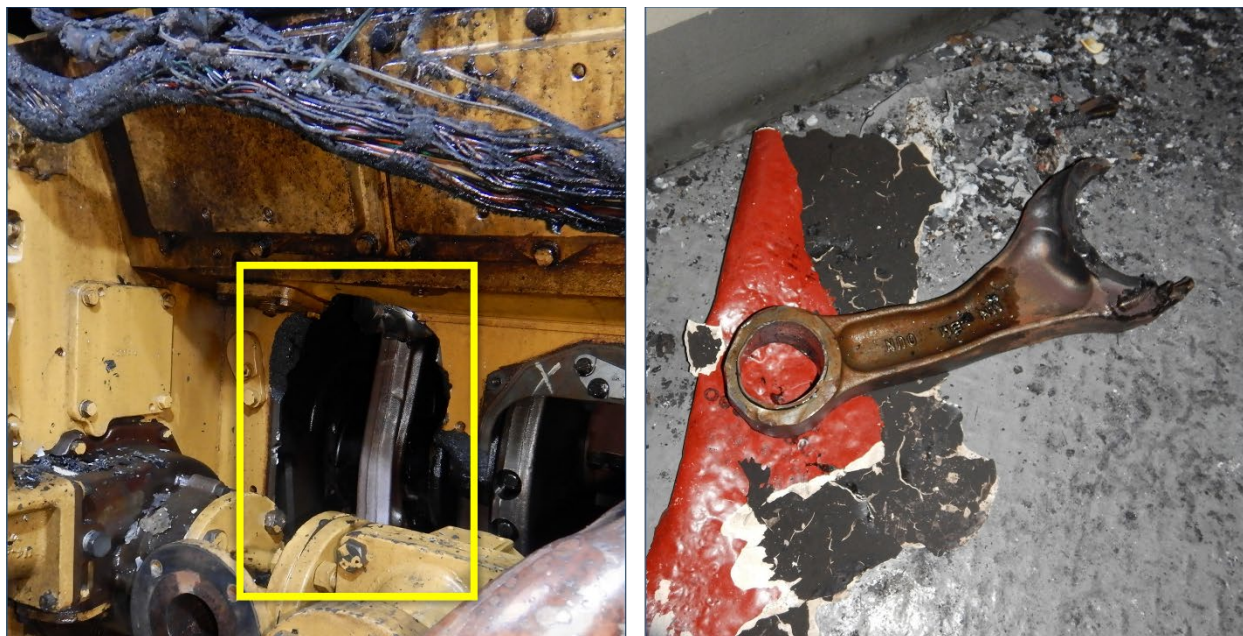
Crewmembers then began taking temperatures of the decks above the engine room using an infrared thermometer. At 1328, baseline temperatures of 95° and 87° on the port and starboard sides, respectively, were established; thereafter, readings were taken every 30 minutes. Once the temperatures began a downward trend, the fire team reassessed the situation visually from the EOS. At 1518, they reported that the smoke had cleared significantly and there was no sign of fire. At 1945, the chief engineer and two firefighters from a responding marine salvage team entered the engine room and determined the space was clear from any immediate fire danger. On the outboard side of the no. 3 DG they observed a damaged connecting rod, which had been ejected from the crankcase, and determined this mechanical failure was the cause of the smoke and fire alarm.

**Figure 3.** The damaged section of the engine (*left*), as indicated by the yellow square, from where the connecting rod from the no. 3 DG (*right*) was ejected. (Source: Oceaneering International, Inc.; Coast Guard)

The no. 3 DG was damaged beyond repair. Caterpillar technicians and crewmembers removed the damaged engine from the vessel and replaced it with a spare engine. As a result of the engine failure, the area in the engine room around and above the no. 3 DG suffered smoke and heat damage. Propulsion control systems, lighting fixtures, electrical cables and components, and air ducts required repairs and/or replacements.

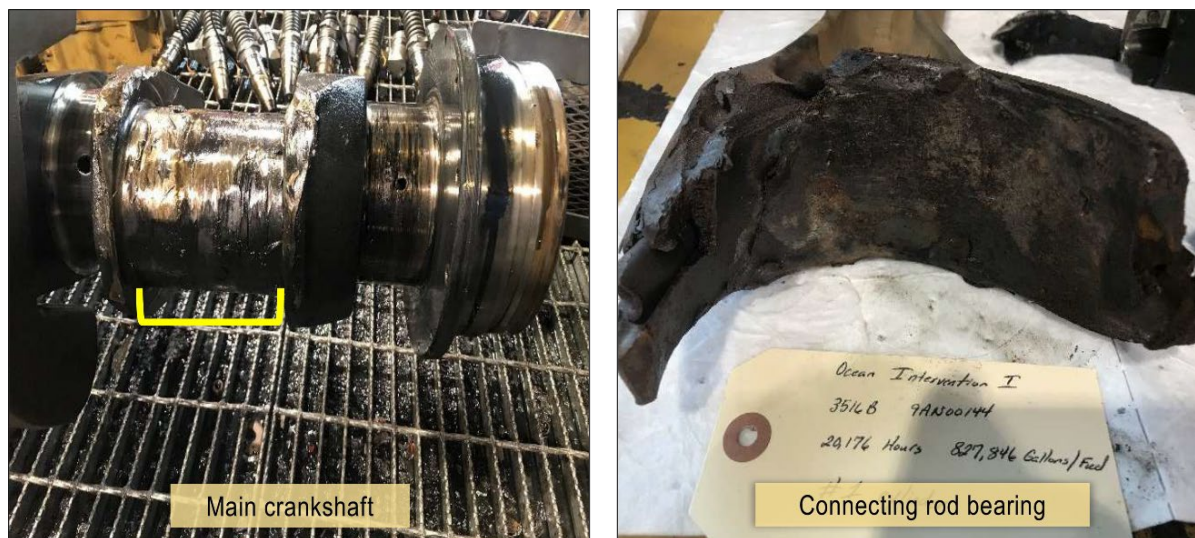
The damaged engine was shipped to Louisiana where factory-trained representatives conducted a forensic teardown to document the condition of the engine's various components and develop a failure investigation report. The report concluded that the engine failure sequence began when the no. 1 connecting rod bearing began to adhere to the crankshaft, causing the no. 2 connecting rod bearing to overheat and adhere to the crankshaft as well. As a result, heat began to transfer down to the no. 1 main bearing, causing the bearing to adhere to the crankshaft and thereby spin in the crankshaft bore. As the failure progressed, both pistons contacted the cylinder heads, until the no. 1 connecting rod was pulled from the piston and contacted the crankshaft counterweights and the no. 2 connecting rod. The no. 1 connecting rod was ejected out of the crank case.

The report stated that, as a result of the engine failure, the engine block had been ventilated at the nos. 1 and 2 cylinders, and the nos. 1 and 2 connecting rod bearings had spun and disintegrated into small thin pieces. The remaining connecting rod bearings showed signs of bearing cavitation, some of which appeared "to be severe." Slight grooves appeared on the worn main bearings. Technicians also noted that there were signs of piston-to-cylinder head contact, but all the valves were in place and intact. The no. 2 cylinder injector tip had damage from contact with the piston.

**Figure 5.** The yellow bracket identifies the damaged area of the main crankshaft of the no. 3 DG (left), where the no. 1 connecting rod bearing failed (right). (Source: Oceaneering International, Inc.)

The National Transportation Safety Board determines that the probable cause of the diesel generator engine failure aboard the offshore supply vessel *Ocean Intervention* was a cylinder's connecting rod bearing adhering to the crankshaft, which led to the ejection of the connecting rod and catastrophic damage to the engine.

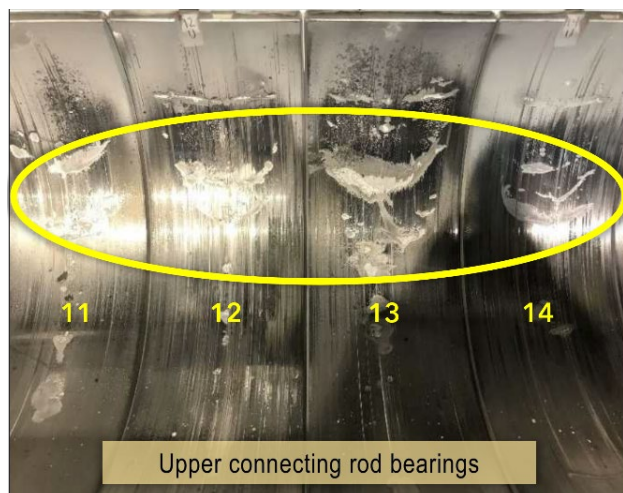
Another possible cause of the failure was the condition of the bearings. Several of the rod bearings showed signs of cavitation erosion, a degradation of a bearing resulting from vapor-filled cavities in the lubricating oil that may include loss of material, surface deformation, or changes in properties.

**Figure 6.** Cavitation erosion in upper connecting rod bearings from the no. 3 DG in cylinder nos. 11, 12, 13, and 14, encircled. (Source: Oceaneering International, Inc.)

The report explained that cavitation erosion was normal over the life of a bearing, indicating that “the [cylinder] number 13 rod bearing showed the most wear and would be considered excessive...If the cavitation erosion became excessive enough, it could cause the bearing to fail and set off the chain reaction” of the failure sequence.

Lastly, the *Ocean Intervention's* manager for maintenance and repairs stated that the frequency of inspections for main and connecting rod bearings on the model 3516 engines installed aboard the Oceaneering vessels would be reduced from 21,500 hours to between 10,000 and 12,000 hours to allow the bearings to be inspected and replaced early out of an abundance of caution. The connecting rod bearings would be replaced following inspection, as they were not able to be used again after being opened. The main bearings would only be replaced during these inspections if they showed abnormal wear. The technicians stated that Caterpillar had no issue with increased inspections and staying within the operational maintenance manual guidelines.
